Johan Sentjens,
Temati BV, the
Netherlands, discusses
the pitfalls of insulation
applications on LNG
projects.

KEEPING COOL

A case study

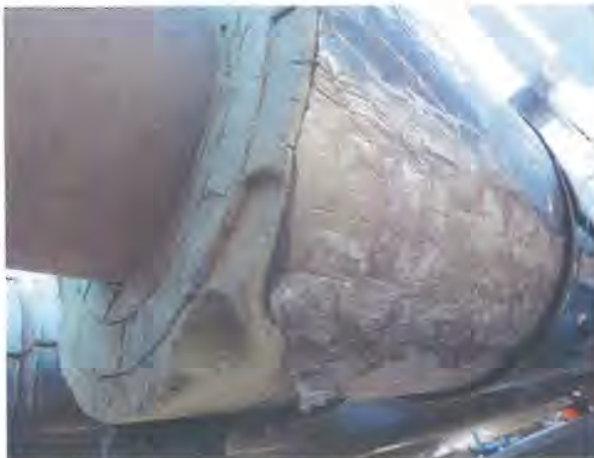
Figure 1. Primary vapour barrier aluminium foil with localised corrosion at the lower half.

Other shortcomings were also found during the site inspection. One of the findings was that the primary vapour barrier (PVB) was damaged due to galvanic corrosion and puncturing by self-tapping screws in the cladding. After further investigation at some 50 spots throughout the jetty area and the plant, it became clear that an unsuitable primary vapour foil was applied. This, in combination with the stainless steel cladding, had led to galvanic corrosion.

The applied PVB consisted of a butyl rubber adhesion layer covered with a single layer of aluminium foil. In this case, the aluminium layer and the seawater was in direct contact with the stainless steel cladding, causing galvanic corrosion.

The time span between shipping from the prefabrication location to inspection covered several years. In many places it was found that the aluminium layer was completely corroded away.

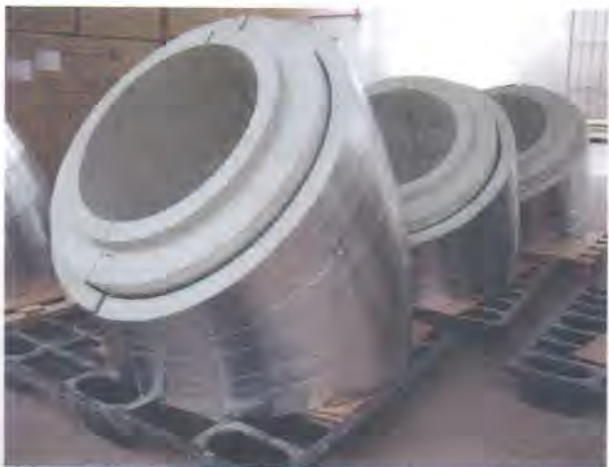
Figure 6. Prefabricated elbows with Tembutil-IF.

With regards to elbow joints in the loading lines, the project management team decided to completely re-insulate all elbow joints, as well as the outer layers of the adjacent straight sections. After considering various options, the quickest method was to replace all elbows by prefabricated sections.

The philosophy in these 'bush fires' is always a two-way action. Short-term 'fire fighting' and long-term action to ensure it does not happen again. The 'fire fighting' involved teaming up with the PIR manufacturer. Temati and the PIR manufacturer organised to factory-apply Tembutil-IF to pre-cut PIR pipe-sections and elbows. An overlap of Tembutil-IF on all pipe sections on the longitudinal side makes on-site application easier. The company supplied Tembutil-IF tape for circumferential joints and Tembutil-IF in pre-cut fish-tail shapes adapted to the 3D elbow model for the bends. Wrapping vapour barrier foil around elbows onsite always brings a risk of not maintaining enough overlap, which is the vital and critical detail of the total vapour barrier. Applying this in a conditioned factory

This project became the start of a new system to supply pre-formed PIR sections, which can be produced for all common shapes (T-joints, elbow joints and valves etc.), and finished with a Tembutil-IF vapour barrier. The system has several significant advantages, including reducing the risk of errors. Traditionally, when applying Tembutil-IF on-site, at least two workers are needed, one on each side of the pipe, to position the foil over the insulation in such a way that it can be applied and pressed onto the insulation in one single pass. Once the Tembutil is fixed to the insulation material it is not possible to correct it. When working in small areas (which seems to be more a rule than an exception) this procedure increases the risk of errors. Finally, by reducing labour on-site, the new system contributes to HSE goals.
